Property Address: 1706 Shoemaker Dr, Killeen, TX 76543

Frontier Real Estate Inspections

Date: 4/4/2015	Time: 09:00:00 AM	Report ID: 040415SW
Property: 1706 Shoemaker Dr Killeen TX 76543	Customer: Judi Binnie	Real Estate Professional: Tricia Daley Exit Home Vets RE

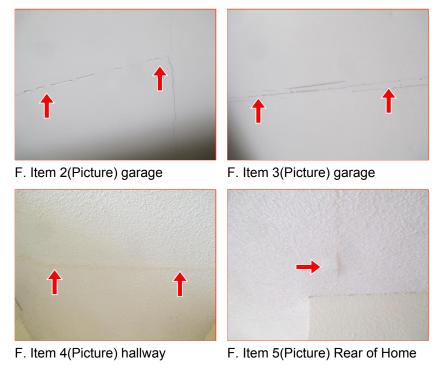
F. Item 1(Picture) garage

(1) The Drywall on the ceiling is peeling as a result from water leak above at the garage. The moisture meter was used and it did not indicate an active leak. While this damage is cosmetic, it needs to be repaired. A qualified professional should repair and or replace all affected areas as needed..

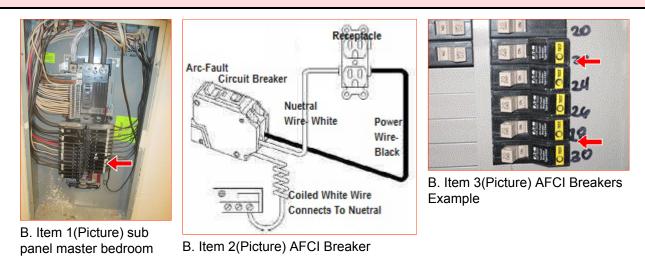
closet Diagram

(1) AFCI (Arc Fault Circuit Interrupter) breakers are not present at the 15 & 20 amp circuit breakers at the branch circuit panel. As of 2008 all 15 & 20 amp circuits should have these type breakers. Areas exempt from this requirement are bathrooms, kitchens, garages, basements. Recommend Licensed Contractor for advisement on this upgrade. (Safety Upgrade)

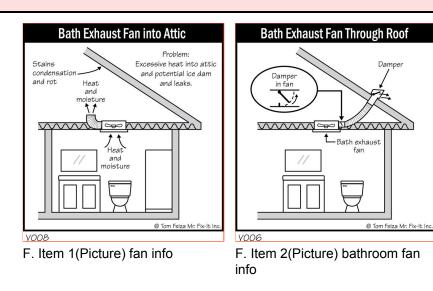
The Exhaust fan and heater fan does not vent to outside at the hall bath and main bath. Vent pipes that terminate in attic space can sometimes cause moisture that can lead to mold or cause condensation. A qualified contractor should inspect and repair as needed..
