SUMMARY

Sample Report , Johnson City ,
Tennessee 37604
John Doe
March 23, 2025

Michael Ray
Tennessee Licensed Home Inspector.
Internachi Certified. Radon Testing.
Thermal Imaging. Energy Audits.
Tennessee Licensed Building Contractor.
Certified Building Performance Analyst.
Home Check Inspection Services, LLC.
(423) 791-1264
homecheckinspect@comcast.net

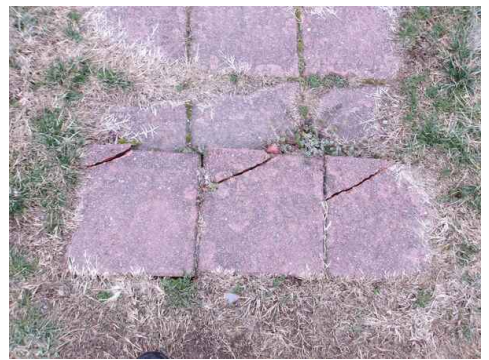
2.2.2 Sidewalks

There is some cracking of the home's front sidewalk pavers. Minor cracks are those less than 1/4 of an inch with no displacement. Major cracks are considered those greater than 1/4 inch wide and / or with displacement (raised or lowered edges) around the crack. If cracks are raised (displaced) they could be considered a tripping hazard. Cracking may be due to age or indicate movement in the soil. Upheaval could be caused by tree roots, while sinking areas may be the result of uneven soil settlement.

Continued exposure to rainwater, with water entering cracks, may result in further damage from soil erosion or upheaving of the sidewalk from water freezing. Recommend repairing / patching / sealing and monitoring cracks to help avoid water entry and / or further cracking.

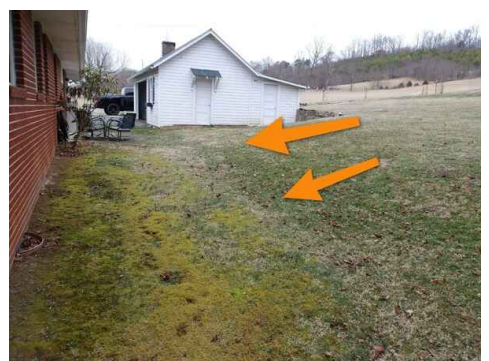
2.4.2 Grading and Drainage

The general slope or grade of the soil in areas of the upper back yard is toward the home. This design may direct water not absorbed by the soil toward the home, which may lead to water build up along the home's foundation. Recommend developing and maintaining a soil grade that will direct water away from the home. If the soil drainage way from the home cannot be corrected one may consider the addition of a drainage system (French Drain), if not already in place.

back yard soil grade is negatively sloped toward the home

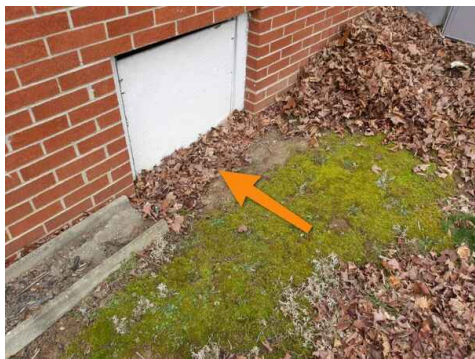
Water is one of the leading causes of damage to a home. Water infiltration of a foundation wall or structural issues due to hydrostatic pressure or soil heaving or freezing is always possible. To help remove water from the base of the home's foundation the soil around the home should be positively sloped in order to direct water away from the home. A soil grade where the soil is at least 6 inches higher at the home than 10 feet away (5% grade) is recommended.

relatively flat soil grade, at base of foundation, right side of home

Contact a qualified landscaping contractor

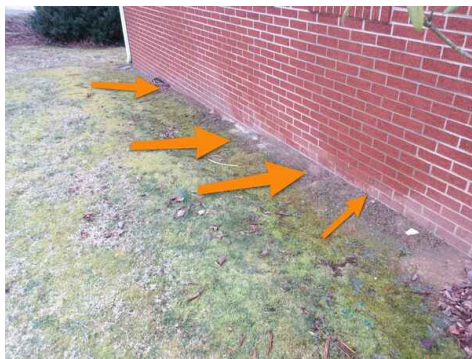
negative soil grade, water not absorbed by the soil will drain toward the foundation, back left of home

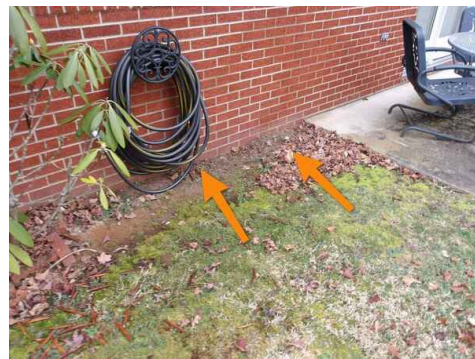
flat soil grade along foundation, back side of the house, left of the back patio

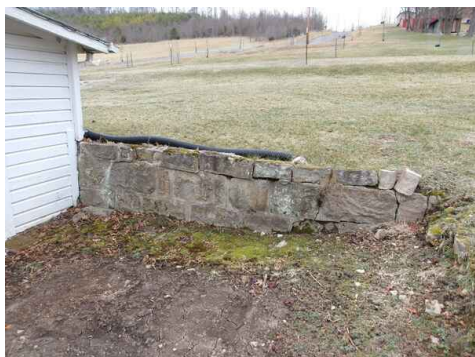
back yard retaining wall

There is no visible drainage system for the back yard retaining wall. Instead the gutter downspout off the detached garage is releasing water behind the wall. A drainage system should be installed around brick, block, rock, or concrete retaining walls to help drain water or release water pressure (hydrostatic pressure) from behind the wall. Normally, a retaining wall drainage system will release water at the front or sides of the retaining wall.

Recommend the wall be evaluated thoroughly for a drainage system. Overtime soil or vegetation may cover drainage ports. If no drainage system is identified the installation of one should be considered to help reduce hydrostatic water pressure and prolong the life of the wall.

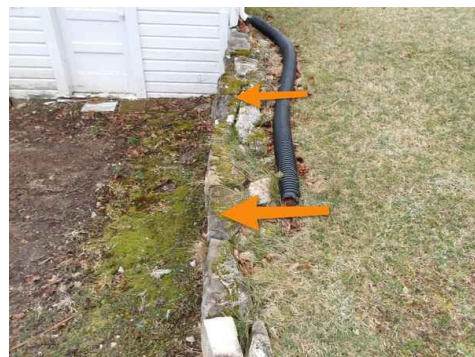
retaining wall slightly leaning, presumably due to soil pressure or hydrostatic (water) pressure

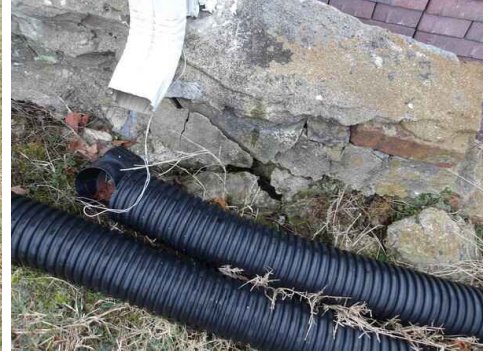
The retaining wall has visible signs of rock deterioration / displacement. Major displacement would include movement or displacement of block / concrete and / or mortar and cracks in excess of 1/4 of an inch.

All cracks should be mortared / caulked or sealed to prevent water entry and thus further damage from water freezing and expanding, mortar deterioration, etc. Recommend repair to help prevent further damage and help retain the life of the wall.

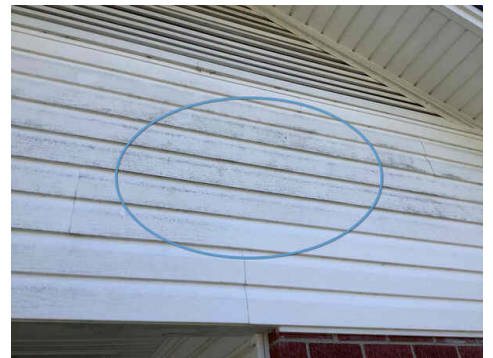
Left side gable end

There are signs of algae and / or mildew on the siding. This is a cosmetic issue and is not uncommon especially on shaded portions of the home. Recommend these areas be washed or cleaned on a regular basis.

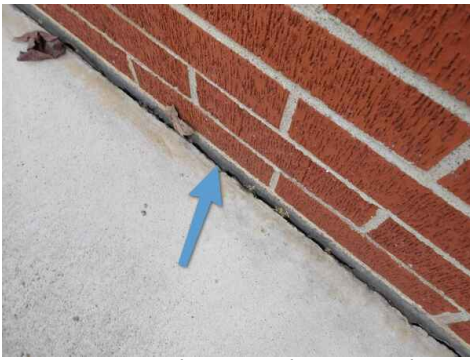
The space or crack between the patio and the home has been caulked / sealed but the caulking is cracking in areas. This may allow water entry along the foundation and may cause soil erosion and thus cracking of the patio surface. Additionally, during the winter months, wet soil may freeze and expanding may raise and crack a patio. Caulking or sealing of gaps in the crack's caulking is recommended.

open areas in the space between the back concrete patio and the brick and mortar cladding

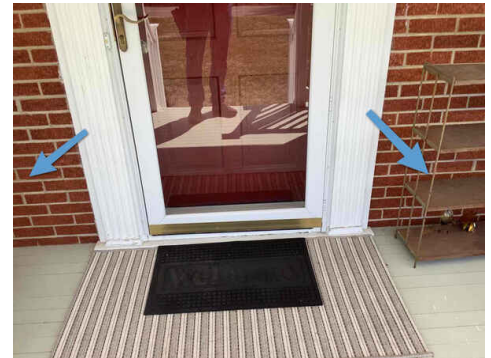
No exterior electrical receptacle, front of home

Recommendation
Contact a qualified professional.

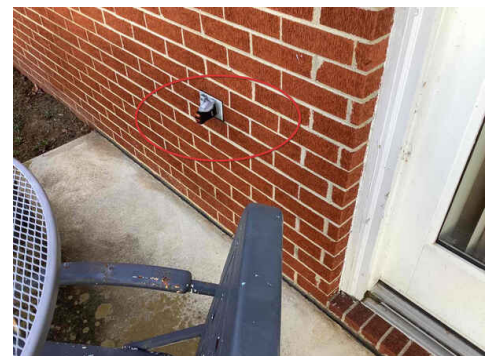
All exterior outlets should be Ground Fault Circuit Interrupters (GFCIs). GFCI protection was required in exterior electrical receptacles in 1975. Although homeowners are not required to upgrade their home's each time new codes are approved (every three years). There are certain codes that are for personally safety and these changes will be recommended when needed. Recommend installing GFCIs on exterior outlets.

Back patio exterior receptacle, no GFCI protection

Recommendation
Contact a qualified professional.

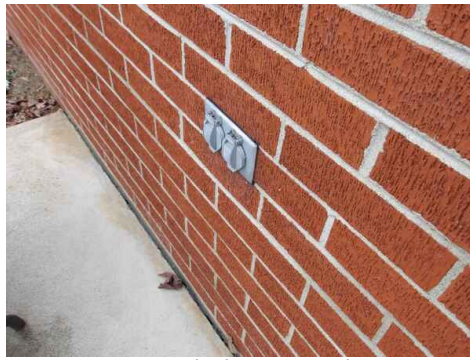
Exterior receptacles should be protected from rain / moisture by having a cover that still protects the receptacle when in use. Recommend installing.

not recommended cover style

Recommendation
Contact a qualified professional.

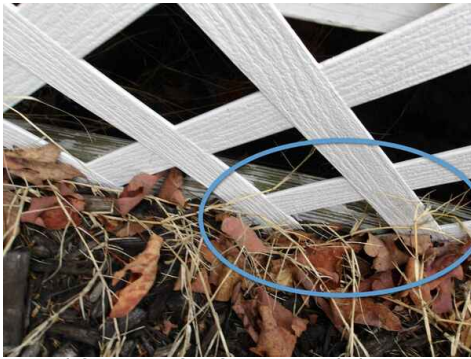
The wood framing for the front porch lattice skirting is in soil contact. All wood, even pressure or chemical treated will rot, given enough time.

wood framing for front porch lattic skirting in soil contact

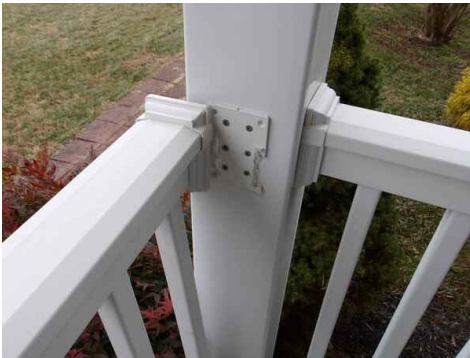
The front porch railing supports are broken / dispatched in areas.

left front top railing connection point broken

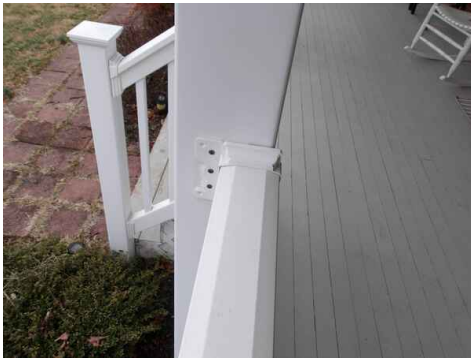
top railing to the right of the front step's connection point is broken

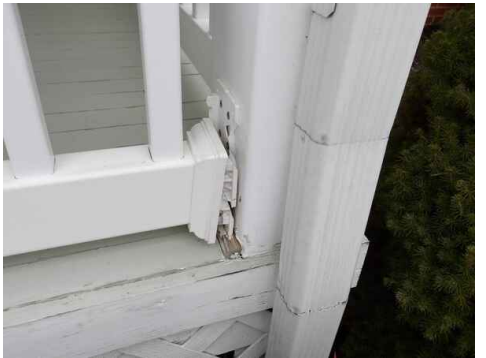
right front corner bottom railing support connection is broken

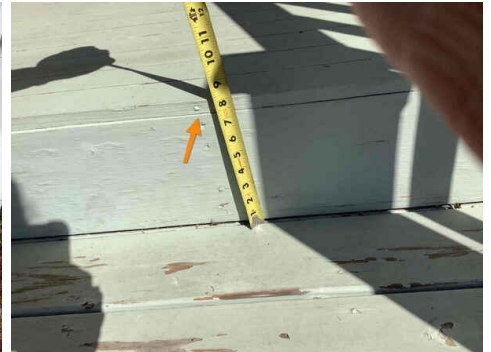
The front porch stair risers do not meet the recommended safety standards with risers higher than 7 3/4s inches. Step riser heights should be no greater than 7 3/4 inches with no riser height variance between step riser greater than 3/8 inches. Care should be taken until one gets used the step height or variance.

Front porch stair riser 8 inches

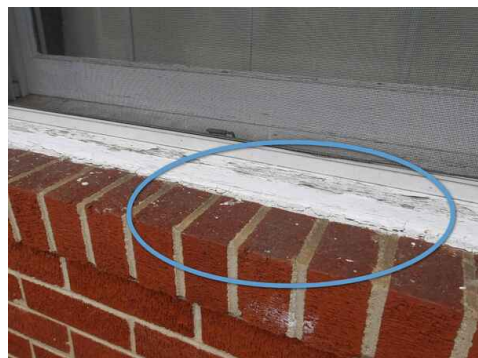
The space between the home's windows and the brick exterior cladding has been heavily caulked, however, there are cracks in some of this caulking material. These cracks / gaps may allow water / moisture entry. These areas may also be energy loss points for the home. Recommend caulking / sealing these cracks / openings / spacing.

cracking in existing window caulking

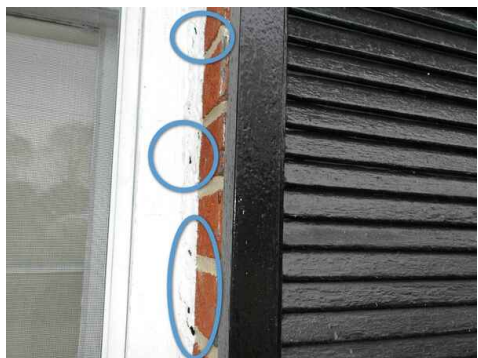
crack / gaps in window caulking

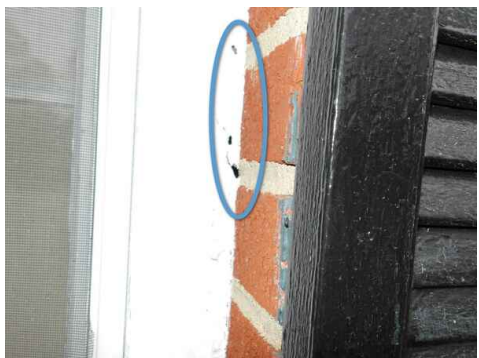
cracks in window / cladding caulking

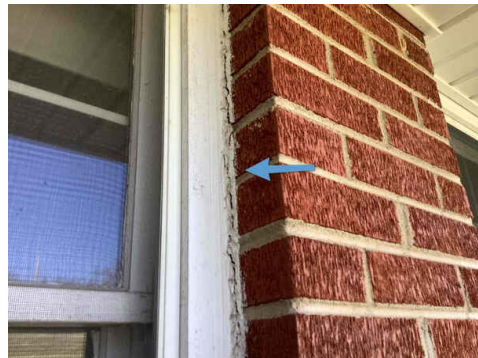
Cracked caulking around some windows, between windows and exterior brick

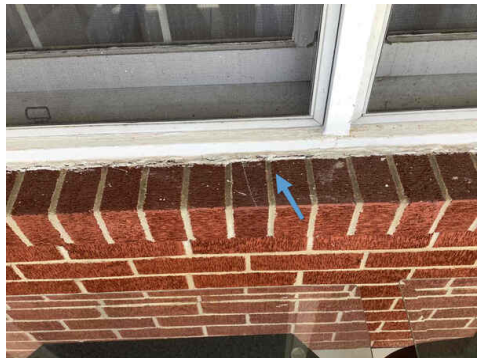
Cracked caulking, base of front living area window

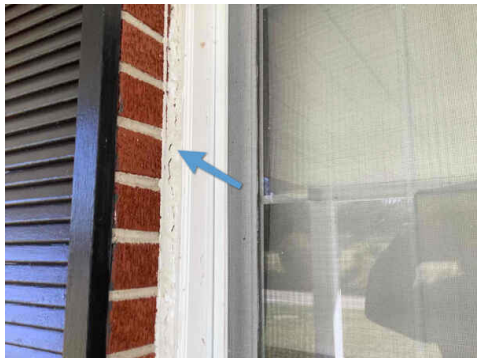
Cracked caulking, side of front living area window

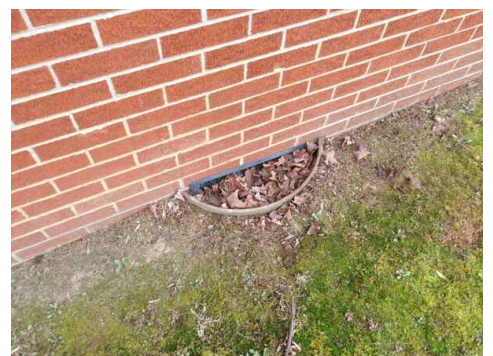
It is recommended that crawlspace vent wells be clean and free of debris in order to prevent the blockage of air flow through the vents.

vent well blocked with leaf debris, back left of home

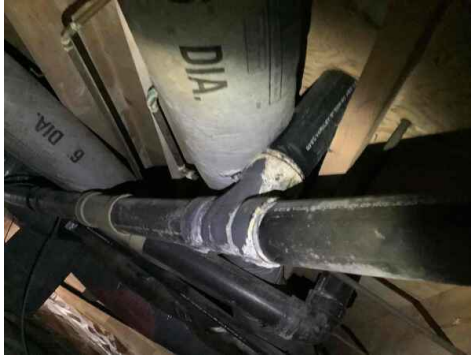
There are signs of plumbing line leaks under the shared bathroom shower and in the ASB drain lines under the bathrooms. Water or water staining of drain lines, water dripping from the lines and / or water pooling on the vapor barrier or the crawlspace soil.

Water puddle under drain lines under back bathrooms

Recommendation
Contact a qualified professional.

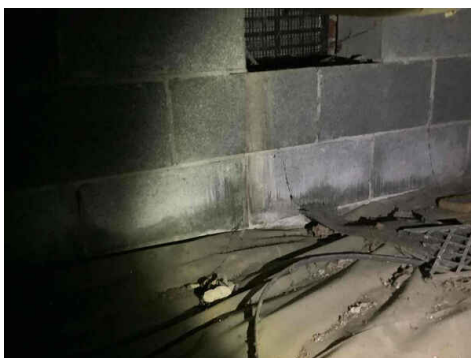
Back right foundation block

Efflorescence was noted on the visible foundation walls at the left front, right front, back mid and back right foundation walls in the crawlspace. Efflorescence is the white, powdery deposit / residue that is consistent with moisture intrusion. Overtime, efflorescence can lead to mold growth. Recommend the source of the moisture be identified and corrected.

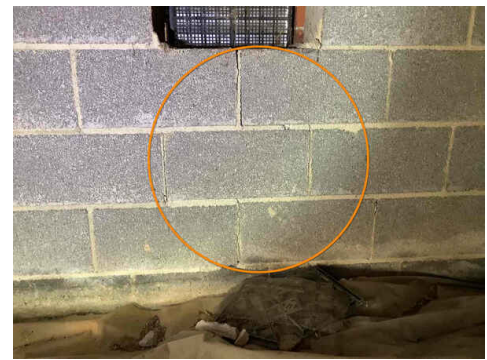
Under right front crawlspace vent

Hairline cracks are typically no cause for concern. These are small, thin cracks that may be found near windows or doors. These cracks could be a relief joint or sometimes they are the result of mortar or concrete shrinkage. It is still never hurts for a specialist to take a look at these cracks to ensure the foundation is stable.

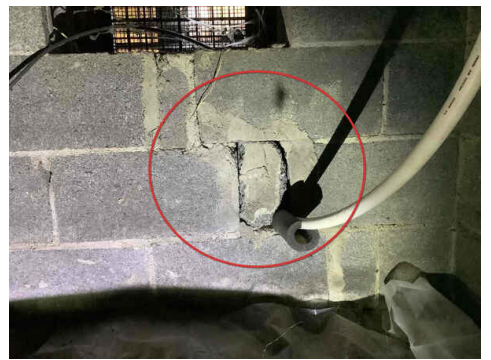
There is visible cracking in the foundation block where the main water line enters the crawlspace through the foundation block at the left front corner of the crawlspace.

Slight damage with displacement at water line entry, left front foundation

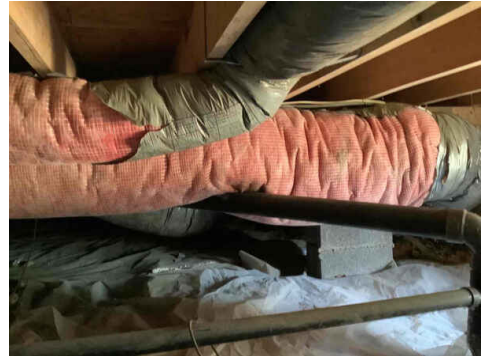
There plastic coating on the outside of the HVAC trunk lines, that holds the insulation in place, is deteriorated and missing in areas. Recommend evaluation and repair.

Plastic that secures the duct work insulation is deteriorating

Contact a qualified professional.

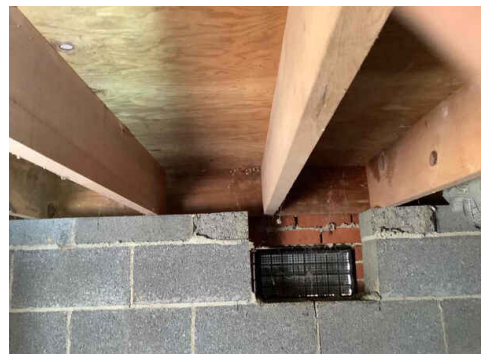
There is no insulation installed in the crawlspace up against or under the subfloor. For crawlspaces in our area insulation with an insulation value of R-19 is recommended. It should be installed with the paper or Kraft side of the insulation firmly pressed against the subfloor between the floor joists without compressing the insulation. Compressing the insulation reduces the insulation factor.

Contact a qualified professional.

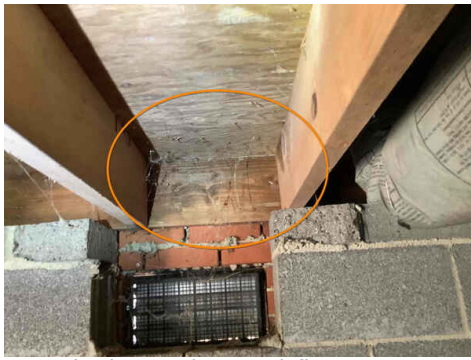
This "microbial growth substance" is normally the result of excessive moisture or a lack of ventilation in the crawlspace.

microbial growth on subfloor

Contact a qualified professional.

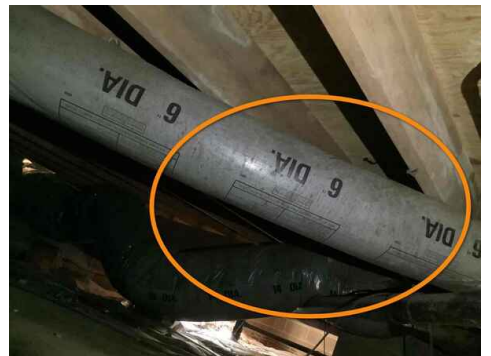
This "microbial growth like substance" on HVAC line insulation is normally the result of excessive moisture or a lack of crawlspace venting.

microbial growth on HVAC duct work
lines

Recommendation
Contact a qualified professional.

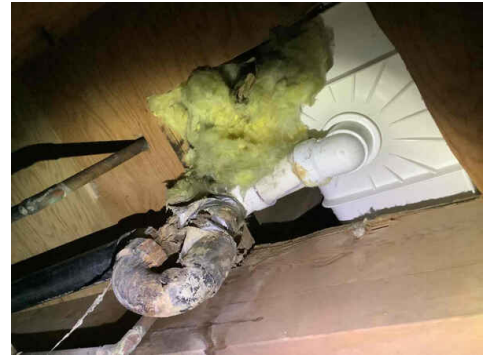
There is spacing around some sub flooring and items that penetrate the sub floor (wiring / plumbing, etc.) that have not been sealed. All areas that will allow the movement of air between conditioned and unconditioned space will also allow the movement of moisture and odors. These openings will also reduce a home's energy efficiency with warmer air moving toward cooler air. Recommend sealing these areas .

Recommendation
Contact a qualified professional.

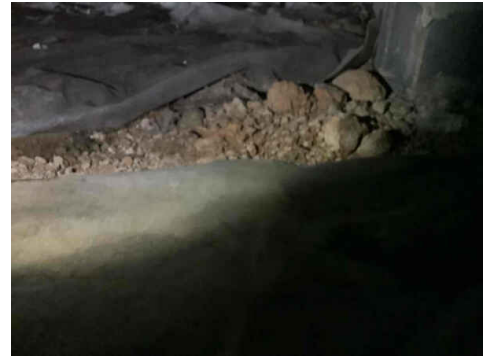
Vapor retarder is improperly installed. This can result in unwanted moisture. Typically, a vapor retarder should be at least 6 mil plastic that completely covers the soil; free of holes and tears; and all seams overlapped at least 6-8 inches and taped / sealed. The vapor retarder should extend up and be secured to foundation walls and support columns. Additionally, the vapor retarded for a manufactured home should no extend out beyond the perimeter of the home and black polyethylene membrane sheeting should be used. Recommend repair or correct installation.

Exposed soil, gaps in plastic vapor retarder

Recommendation
Contact a qualified handyman.

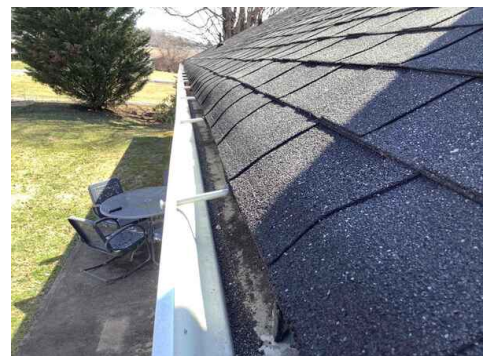
There are shingles at the edges of the roof line that overhang the roof more than the standard / recommended 3/4s of an inch. These overhanging shingles may be heated by the sun and then bend and break along the edge of the roof line. This may then allow water to drain onto the fascia board or the sheathing edge. Recommend monitoring for possible damage.

Shingle over hang 2 inches plus, back side

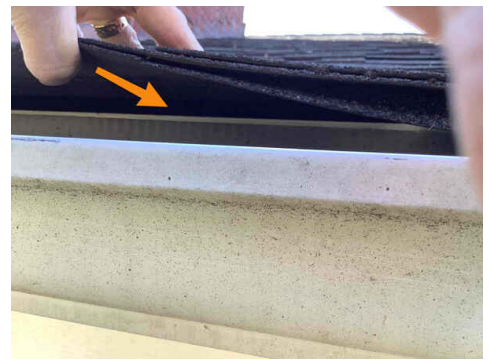
Drip edge flashing should extend at least 1/4 of an inch below the roof sheathing and extend at least 2 inches onto the roof decking. The edge pieces should overlap at least 2 inches. With the absence of a drip edge, it is recommended that the roof decking at the edges of the roof line be periodically checked for water damage.

No drip edge on edge of roof decking

Recommendation
Contact a qualified roofing professional.

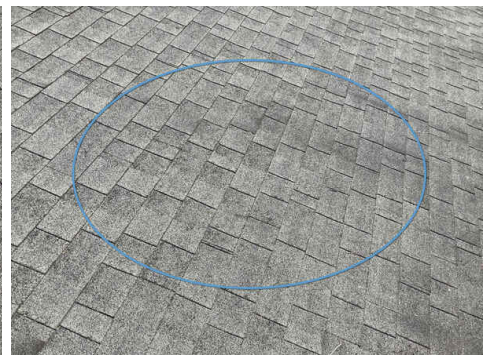
There are areas where the shingles are worn and shedding shingle granules or gravel. This is a good indication that the shingle are wearing and may be nearing the end of their life span.

Granule wear, front roof line

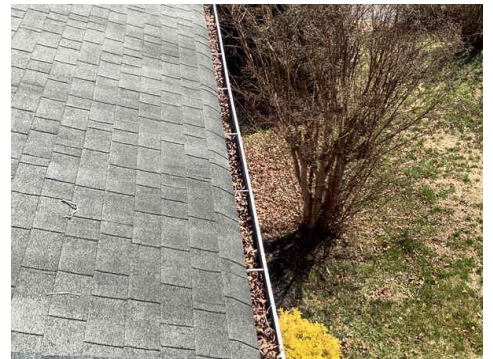
Right front gutter

There is debris accumulated in the gutters. Recommend periodically scheduled cleaning to facilitate water flow and / or the installation of gutter guards to prevent the build up of debris that may clog up the gutters or downspouts.

Recommendation
Contact a qualified handyman.

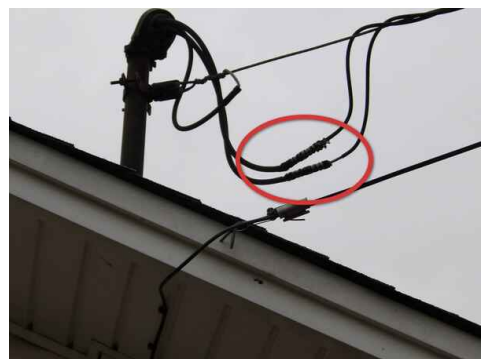
insulation missing on service splices

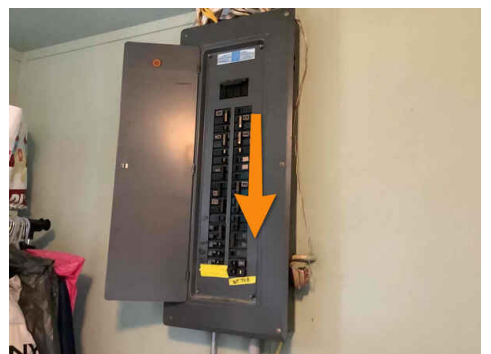
This panel does not meet standard service installation requirements.
To be NEC compliant:

Highest circuit breaker in the panel is
6'11" above the floor

Contact a qualified electrical contractor.

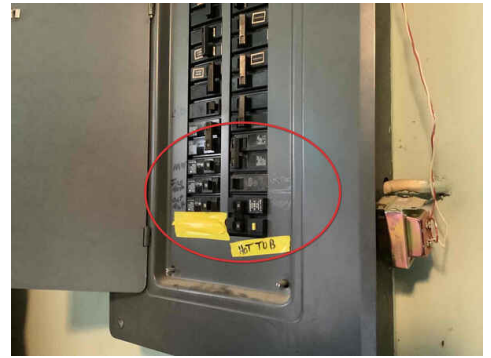
Normally, only the breaker brand that corresponds with the panel brand should be used in an electrical panel. There are individual cases where differing breaker brands will fit in other breaker brand panels. However, a breaker is only tested in the panel they are branded for. Since these non-panel brand breakers have not been tested for this panel brand, it is recommended that a licensed electrician be consulted, and their recommendations for corrections, if necessary, be considered.

GE and Siemens breakers in an I-T-E panel

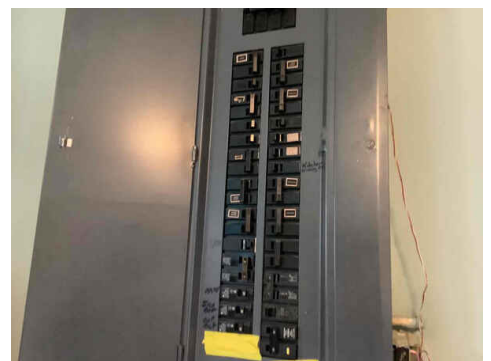
The service panel's directory is missing or incomplete. All service panels should have a complete breaker directory / legend. A directory will allow a specific circuit to be disconnected without shutting off the home's main disconnect. The inspector has no way of confirming the accuracy of the directory, only whether it is missing or appears incomplete. For personal safety a complete circuit directory is required. A licensed electrician should be contacted about developing a panel directory.

No breaker legend, all breakers not labeled

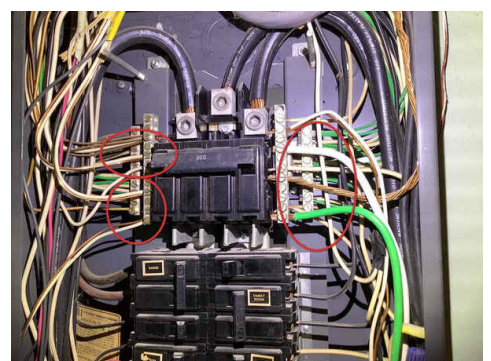
In a service panel grounded conductors (white wires) and grounding conductors (bare wires) are to be separated where secured to the neutral / ground bus bar. In this panel there are neutral and ground wires together, under the same screw, on the bus bar. An individual terminal should be provided for the connection of each branch-circuit neutral conductor. When the neutral is disconnected, the objective is to still have the equipment ground connected. If both the neutral and grounded conductors are under the same terminal, this cannot be accomplished. This needs to be evaluated and corrected, if deemed necessary, by a licensed electrician.

Neutral and ground wires together under same lug on bus bar

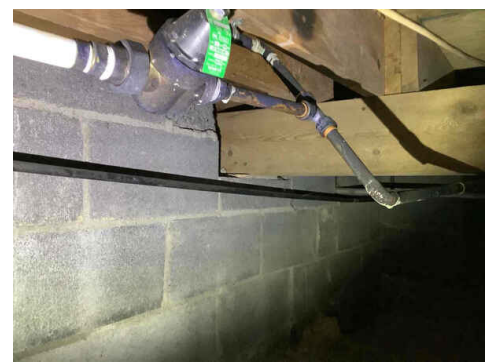
The home's main water shut off valve was not located. Recommend contacting the home's current owner to determine the location and condition of the shut off.

No main water line shut off

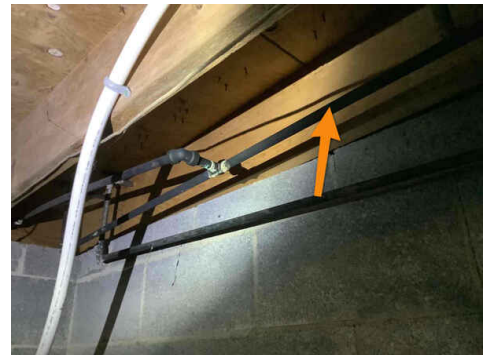
Copper supply lines out insulated

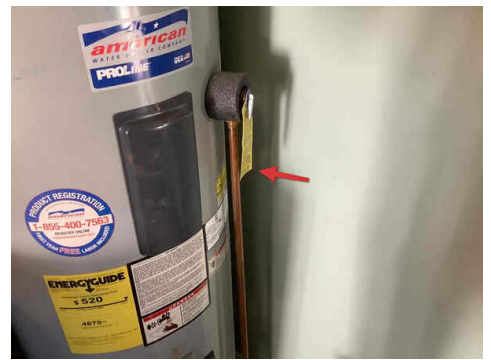
TOR pipe off TPR valve is 1/2 line, 3/4 inch line is required

Recommendation
Contact a qualified professional.

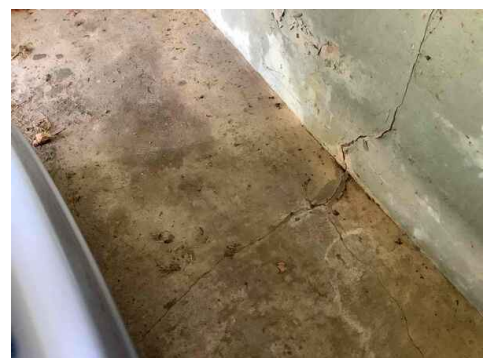
Unfortunately, it is said that "all concrete cracks, it is just a matter of time". There is no sign of displacement (either up or down, or sideways) around the cracking. Recommend patching and sealing.

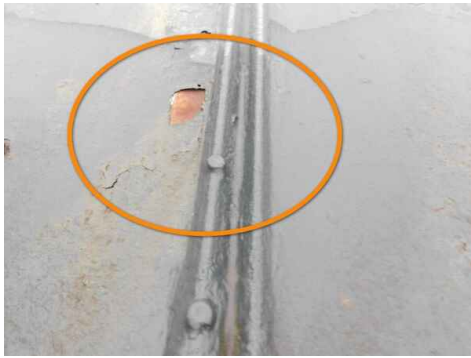
chipped / peeling paint, rust

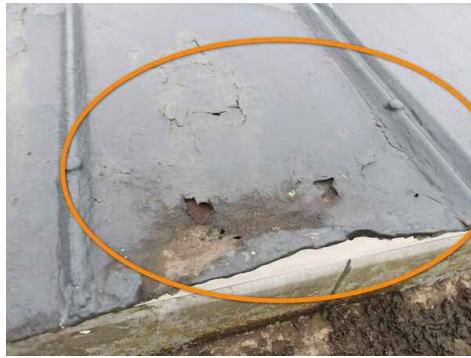
rust, chipped / peeling paint

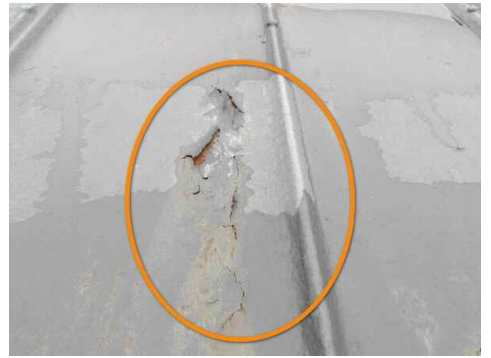
rust / chipped-peeling paint

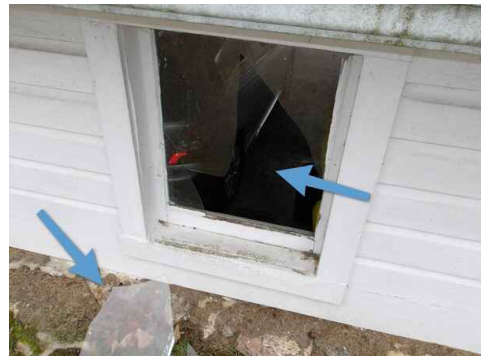
broken window pane, back side of detached garage

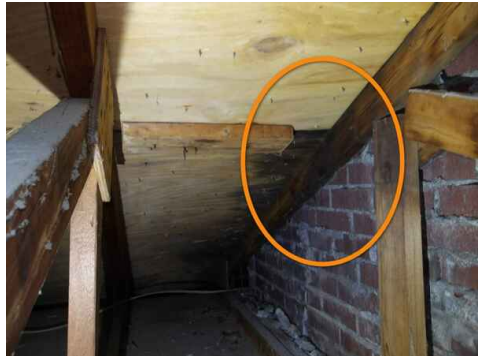
water staining on roof decking on side of chimney

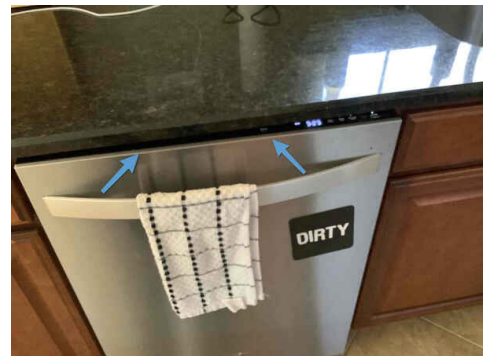
The dishwasher is loose / not fully secured to the base or underside of the countertop. Recommend doing so.

Dishwasher not secured to the underside of the countertop

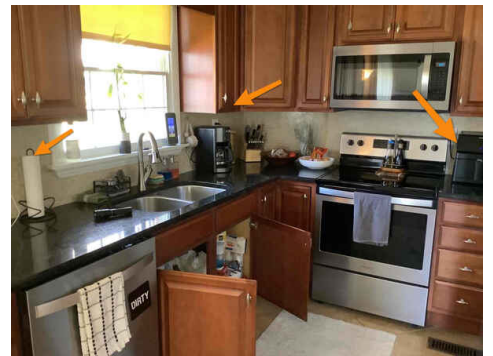
No GFCI protection on kitchen counter top receptacles

Contact a qualified professional.

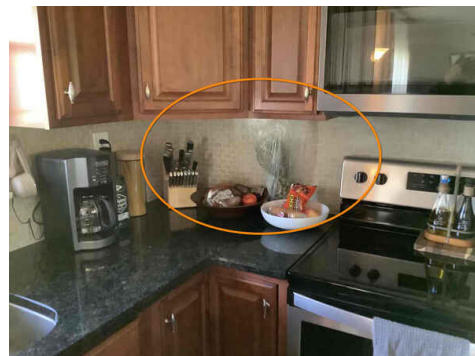
No countertop receptacle

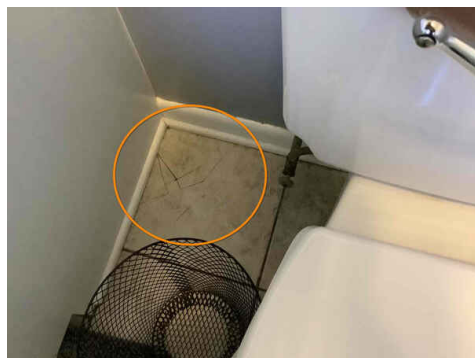
Cracked tile, side of toilet

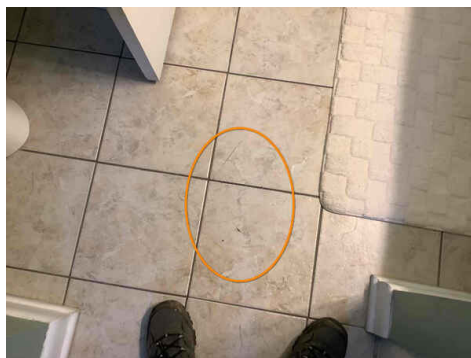
Cracked / chipped floor tile, shared bathroom

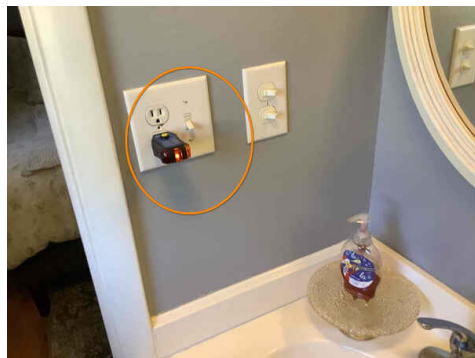
Primary bathroom, vanity receptacle, no GFCI protection

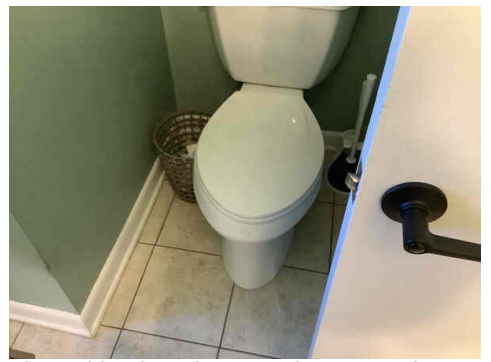
The noted toilet(s) is not fully secured to the floor. If loose on the floor and continually moved the toilet seal could be compressed and begin to leak. Recommend securing. When doing so you may want to replace the seal and while the toilet is off inspect the subflooring around the toilet for possible water damage.

Shared bath toilet, very loose on the floor

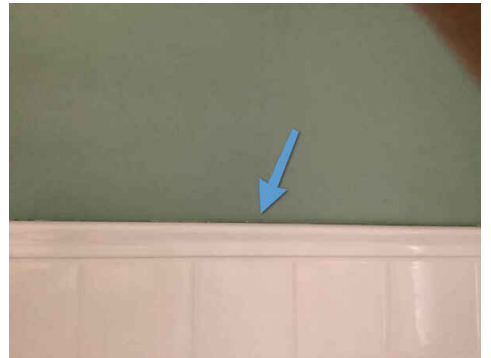
The noted areas around the tub/shower have missing and or cracked caulk or grout. It is recommended to keep these areas caulked to prevent moisture intrusion and damage to the drywall, framing around the shower and to the subfloor or trim.

No caulking above shared bathroom shower enclosure
