Former Board & Nose Refurbishing

Printing: Folders/folding process on Web presses

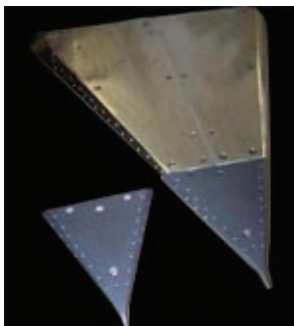
G-16 Former Nose and Board

Refurbished PFF Former Board
