SUMMARY

Sample Report , Johnson City ,
Tennessee 37604
John Doe
March 23, 2025

Michael Ray
Tennessee Licensed Home Inspector.
Internachi Certified. Radon Testing.
Thermal Imaging. Energy Audits.
Tennessee Licensed Building Contractor.
Certified Building Performance Analyst.
Home Check Inspection Services, LLC.
(423) 791-1264
homecheckinspect@comcast.net

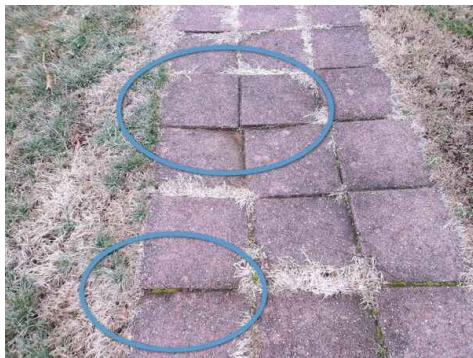
dropped / raised pavers with raised edges

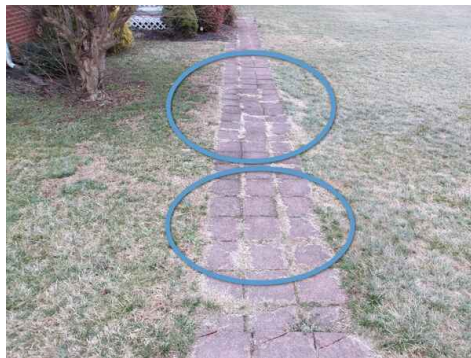
low areas where water may pool, raised and dropped pavers

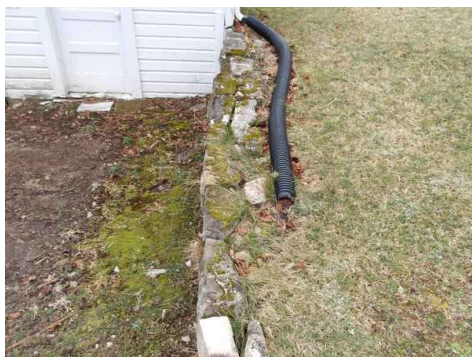
There is no visible drainage system for the back yard retaining wall. Instead the gutter downspout off the detached garage is releasing water behind the wall. A drainage system should be installed around brick, block, rock, or concrete retaining walls to help drain water or release water pressure (hydrostatic pressure) from behind the wall. Normally, a retaining wall drainage system will release water at the front or sides of the retaining wall.

garage gutter downspout releasing water on back side of retaining wall

Recommend the wall be evaluated thoroughly for a drainage system. Overtime soil or vegetation may cover drainage ports. If no drainage system is identified the installation of one should be considered to help reduce hydrostatic water pressure and prolong the life of the wall.

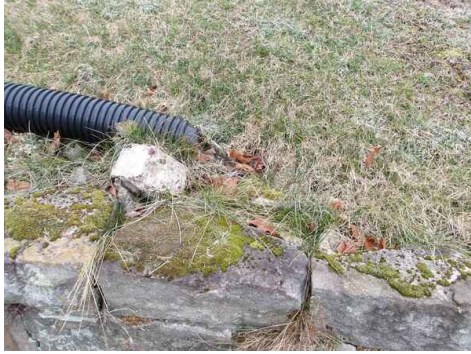
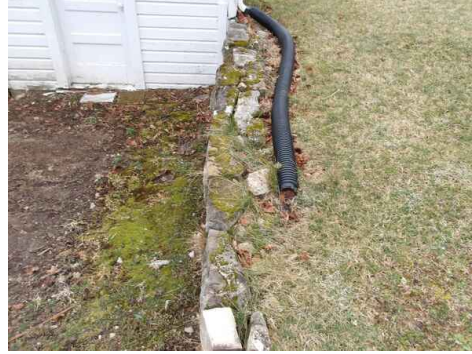
The retaining wall has visible signs of rock deterioration / displacement. Major displacement would include movement or displacement of block / concrete and / or mortar and cracks in excess of 1/4 of an inch.

All cracks should be mortared / caulked or sealed to prevent water entry and thus further damage from water freezing and expanding, mortar deterioration, etc. Recommend repair to help prevent further damage and help retain the life of the wall.

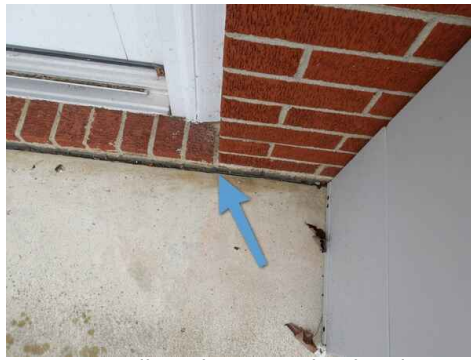
The space or crack between the patio and the home has been caulked / sealed but the caulking is cracking in areas. This may allow water entry along the foundation and may cause soil erosion and thus cracking of the patio surface. Additionally, during the winter months, wet soil may freeze and expanding may raise and crack a patio. Caulking or sealing of gaps in the crack's caulking is recommended.

gaps in caulking between back side patio and exterior brick cladding

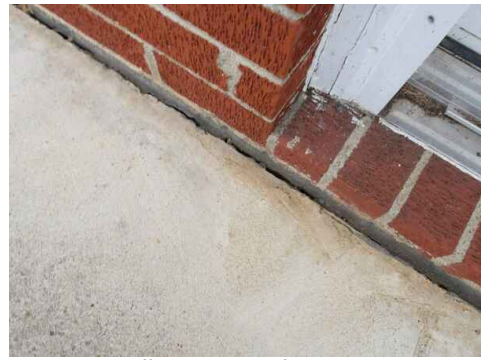
gaps in caulking in gap between patio and exterior brick cladding

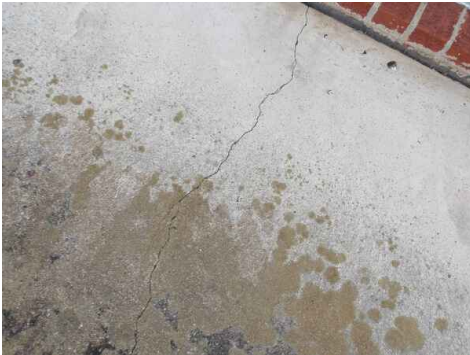
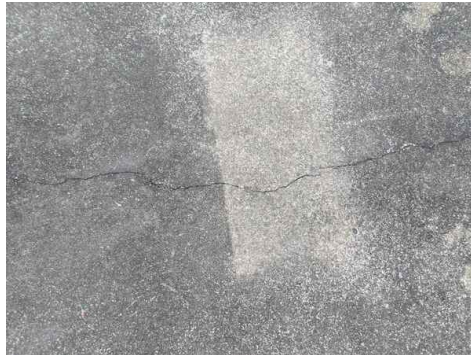
There are visible cracks in the patio slab. There is no raised / displacement areas in the concrete around the cracking.

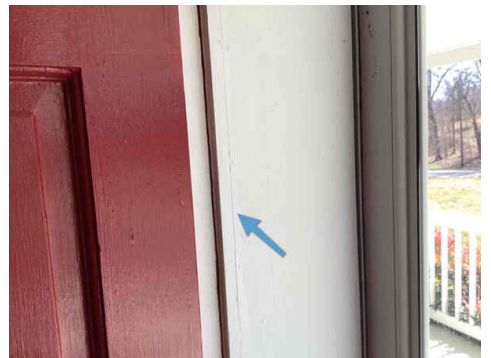
There are areas around the front entry door casing where the weather stripping is not complete or worn.

Front entry, hinge side of door casing, no front door casing weather stripping

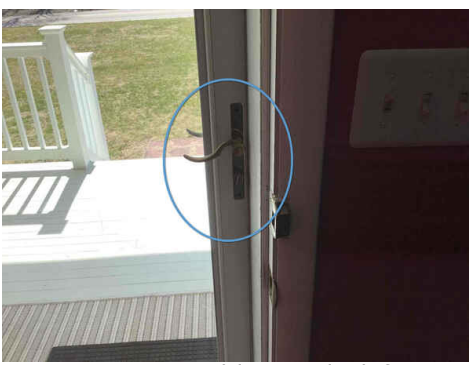
Inspector was unable to unlock front storm door

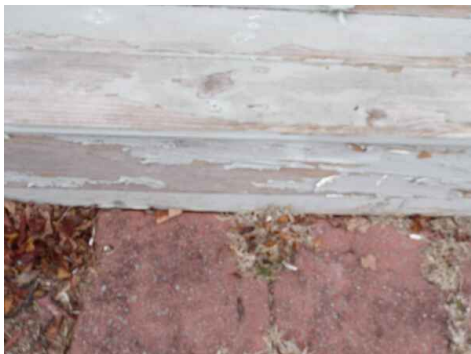
chipped / peeling paint on front porch stairs

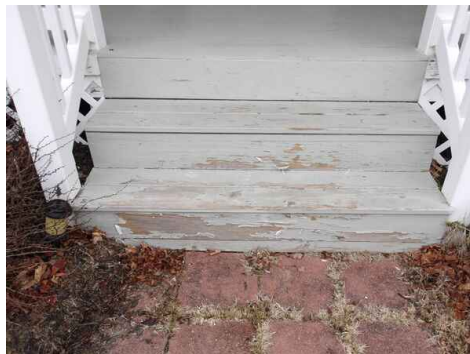
chipped / peeling paint on front porch stairs

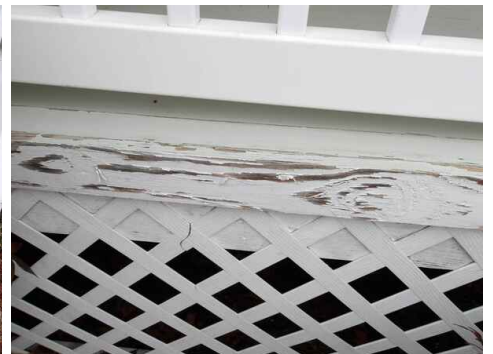
chipped / peeling paint on porch band board

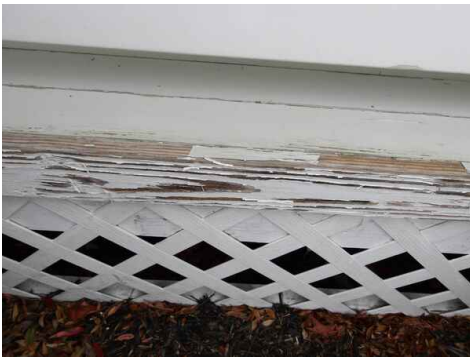
chipped / peeling paint on porch band board

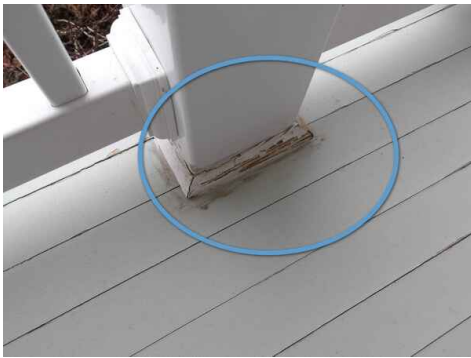
chipped / peeling paint on wood trim at base of porch railing support posts

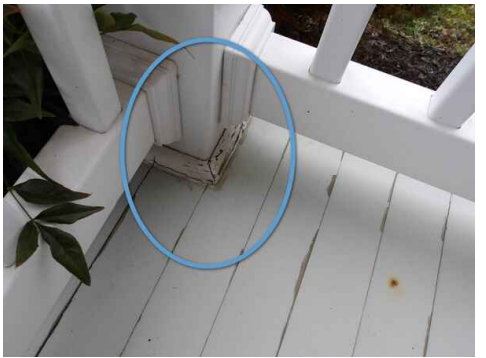
chipped / peeling wood trim at base of front porch railing / covering support post

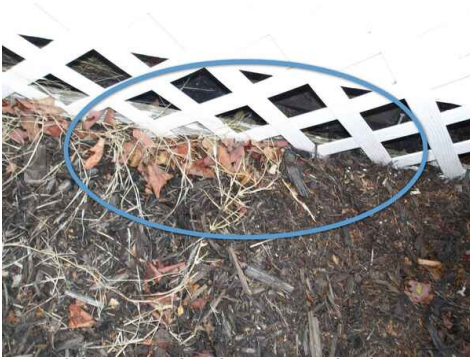
The wood framing for the front porch lattice skirting is in soil contact. All wood, even pressure or chemical treated will rot, given enough time.

wood framing for front porch skirting framing in soil contact

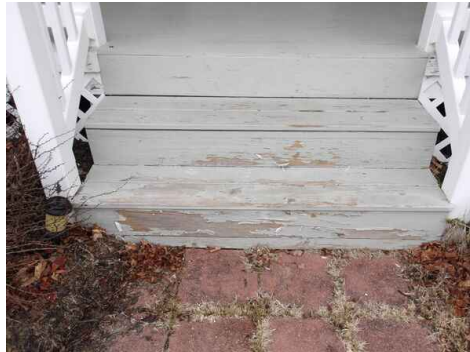
The front porch stair risers do not meet the recommended safety standards with risers higher than 7 3/4s inches. Step riser heights should be no greater than 7 3/4 inches with no riser height variance between step riser greater than 3/8 inches. Care should be taken until one gets used the step height or variance.

Front porch stair riser 8 inches

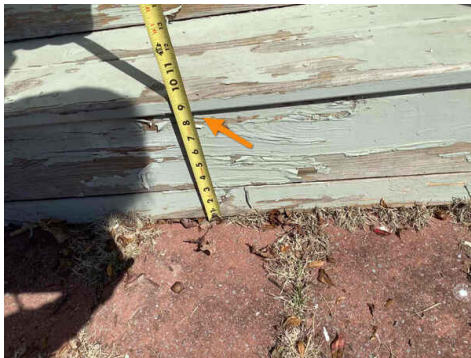
Front porch stair riser 9 inches

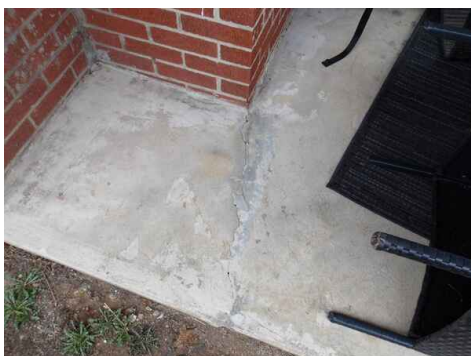
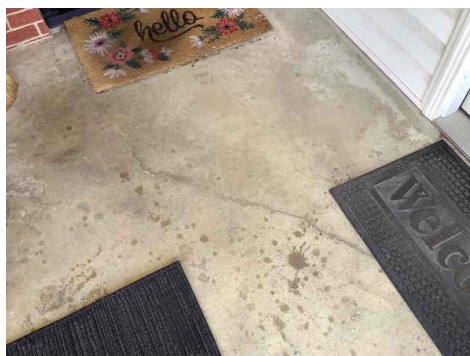
Left side entry concrete slab cracking

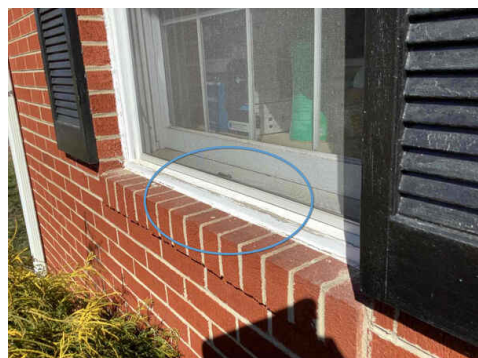
Chipped / peeling paint, front laundry room window

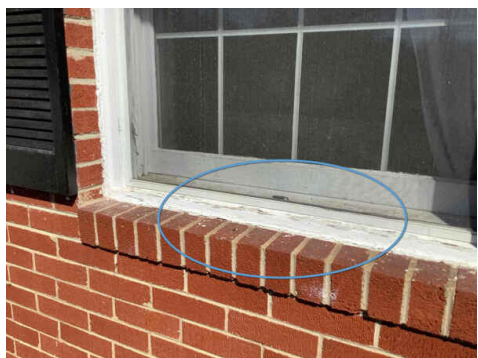
Chipped / peeling paint, right front bedroom window

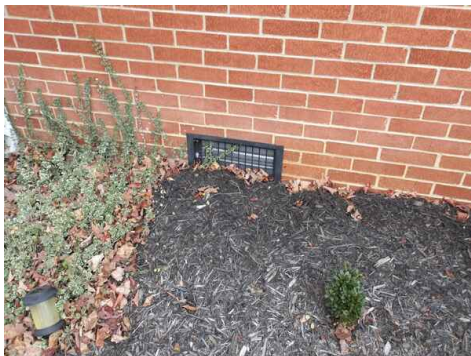
There is soil and / or mulch up to and / or over some crawlspace venting. This may allow water entry into the crawlspace, where moisture needs to be controlled, as well as block crawlspace air flow. If the crawlspace vent framing is wood any moisture may accelerate wood rot. If soil cannot be pulled back without causing a negative soil grade (allows water to pool or drain toward the foundation) then vent wells are recommended around the vent to allow soil / mulch build up without blocking the vent.

soil / mulch over base of foundation vent, front of home

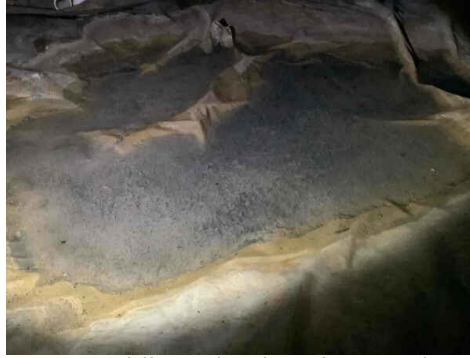
There are signs of plumbing line leaks under the shared bathroom shower and in the ASB drain lines under the bathrooms. Water or water staining of drain lines, water dripping from the lines and / or water pooling on the vapor barrier or the crawlspace soil.

Water puddle under drain lines under back bathrooms

Recommendation
Contact a qualified professional.

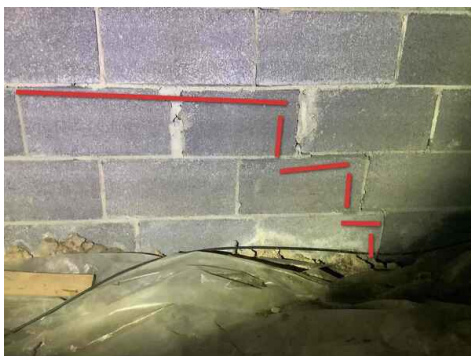
Vertical and stair step cracking, front foundation wall, left of front door, displacement of the block around the cracking

Contact a qualified structural engineer.

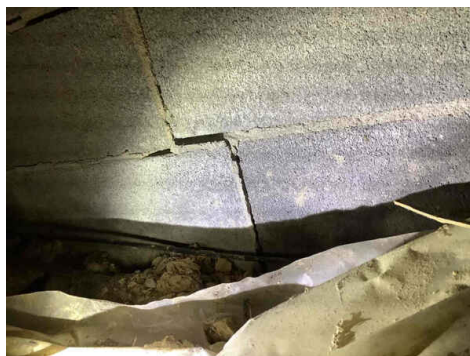
Displacement of the block at the soil line and about 4 blocks up

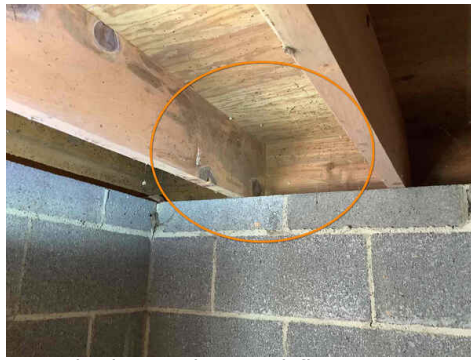
microbial growth on subfloor

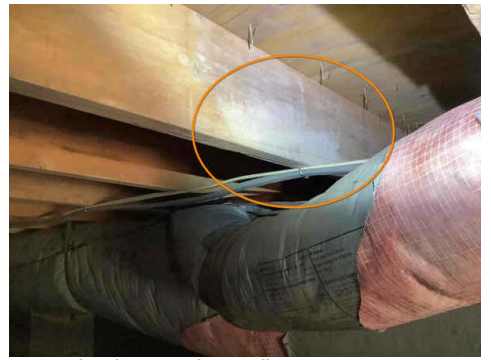
microbial growth on floor joists

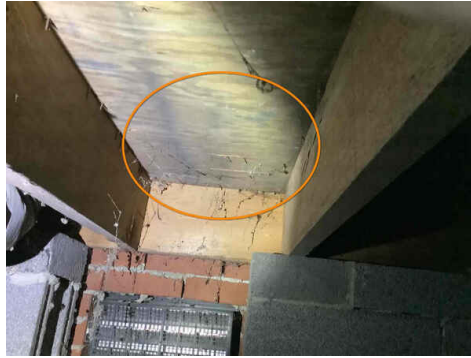
microbial growth on sub floor

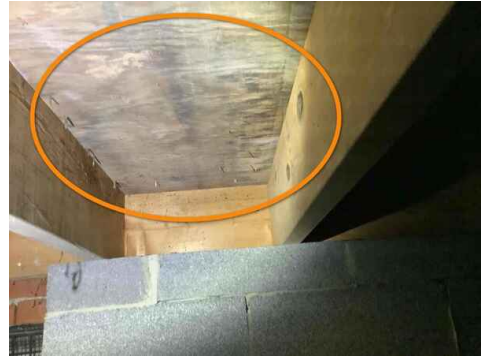
microbial growth on sub floor

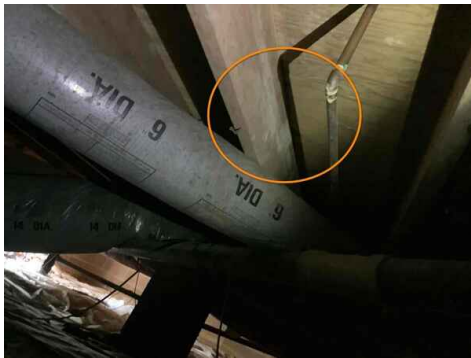
microbial growth on floor joist

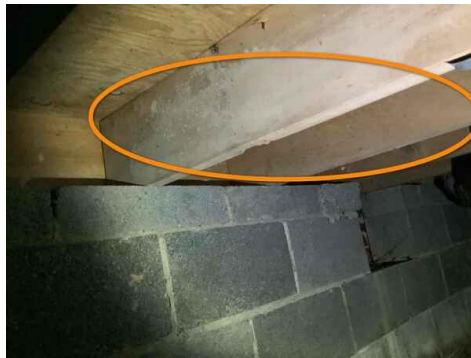
microbial growth on floor joists

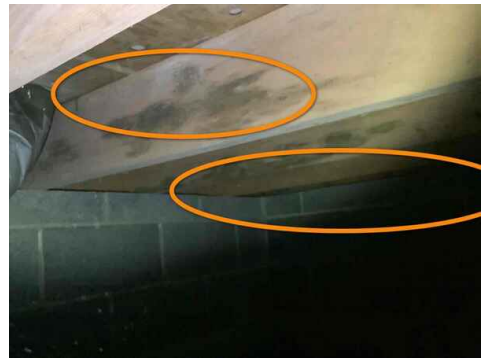
microbial growth on floor joists

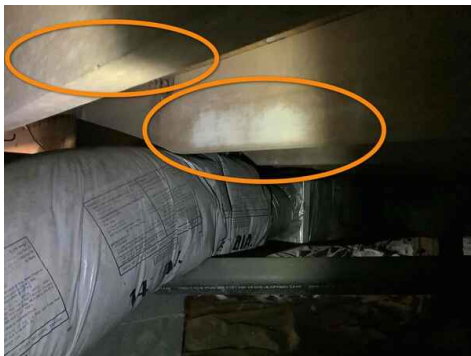
microbial growth on floor joists

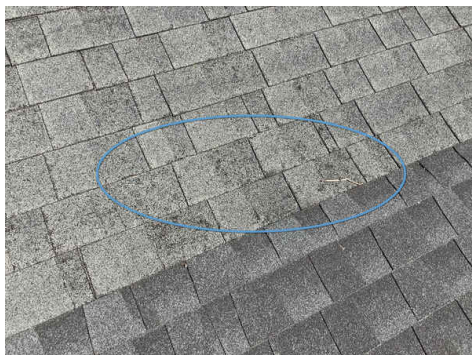
There are areas where the shingles are worn and shedding shingle granules or gravel. This is a good indication that the shingle are wearing and may be nearing the end of their life span.

Granules missing, front

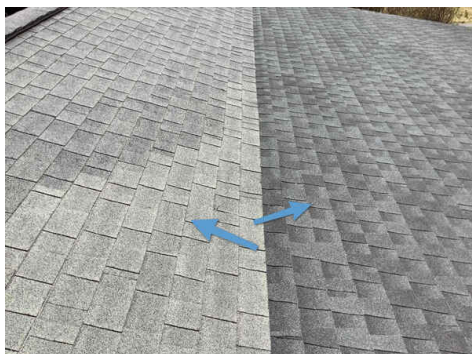
Front porch shingles appear near than the rest of the roof line

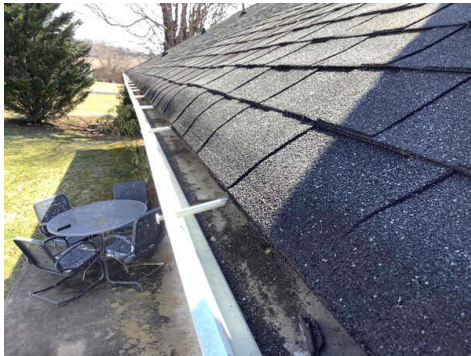
There are no screens or gutter guards installed over the roof's guttering. Gutter screens or guards should be considered where trees overhang the roof or are in the area. Screens or gutter guards will help prevent leaf / tree debris from clogging the gutters or downspouts thus causing water to overflow the gutters and saturating the soil along the home's foundation.

No gutter screening

Recommendation
Contact a qualified professional.

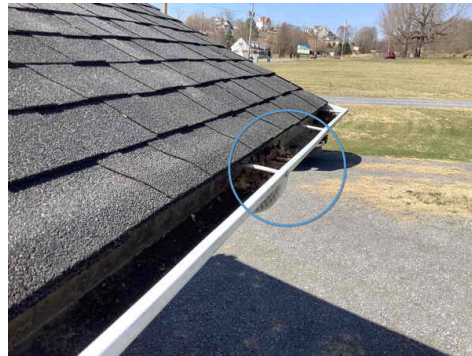
Few area with some leaf debris in gutters

There is debris accumulated in the gutters. Recommend periodically scheduled cleaning to facilitate water flow and / or the installation of gutter guards to prevent the build up of debris that may clog up the gutters or downspouts.

Recommendation
Contact a qualified handyman.

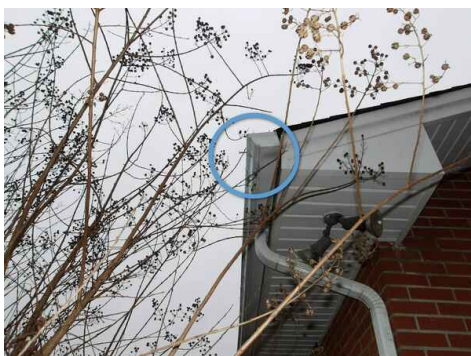
GUTTER NAILS PULLING AWAY FROM HOUSE / FASCIA BOARDS

gutter nails coming loose, right front corner

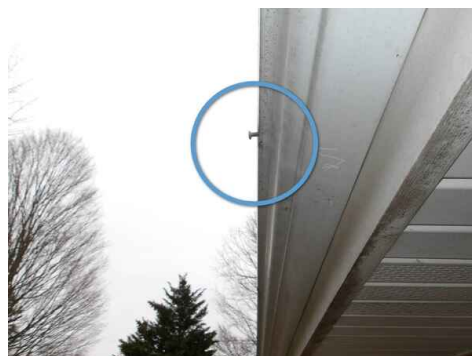
gutter nail coming loose, back left of home

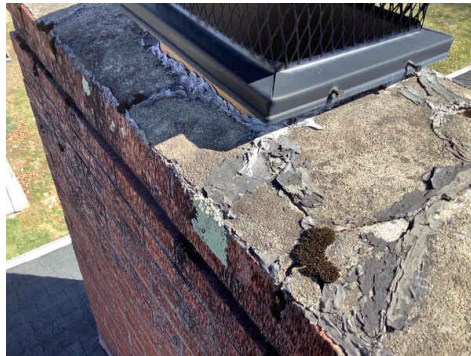
The chimney crown has numerous cracks in its mortar / concrete base. Most cracks have been tared over but the tar is cracking exposing the cracks to water / moisture entry. A properly established chimney cap will move water off the camp while a poorly installed one may allow water to infiltrate the chimney walls, damaging the masonry work. Repairs are recommended.

Cracking of chimney crown, cracking of tar used to seal cracks in chimney crown

Contact a qualified professional.

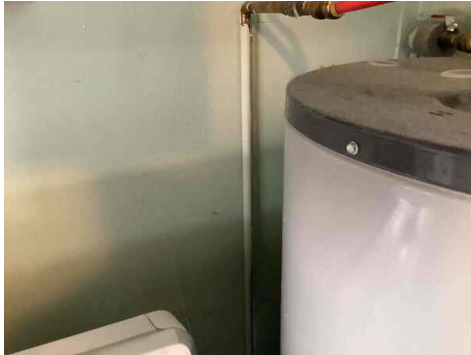
Copper water distribution lines at the water heater are 1/2 inch copper lines, versus 3/4 inch lines

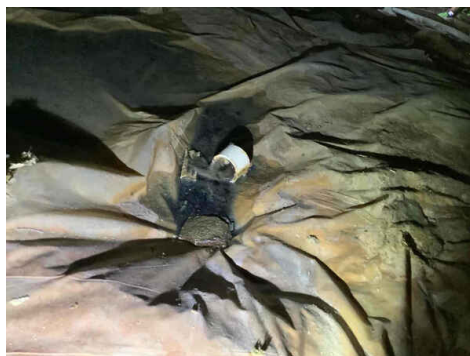
Water on vapor retarder under plumbing leak

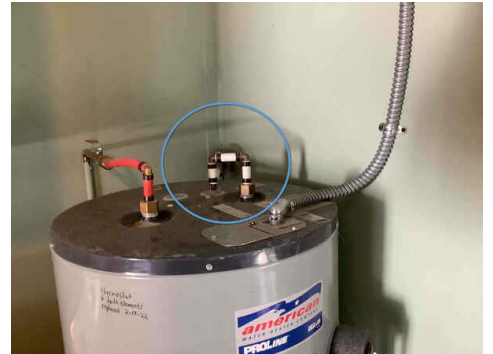
No expansion tank on cold water line

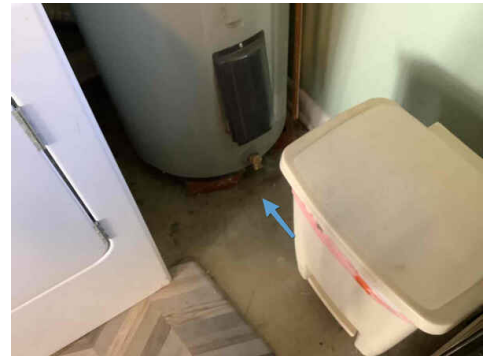
No drip pan under water heater

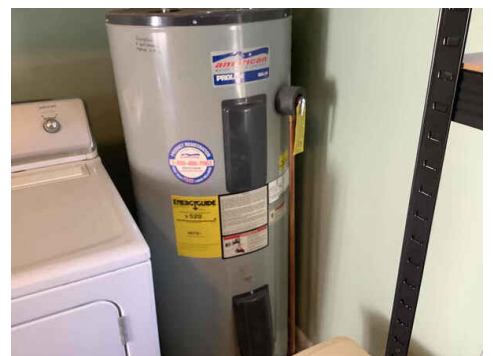
No water heater strapping

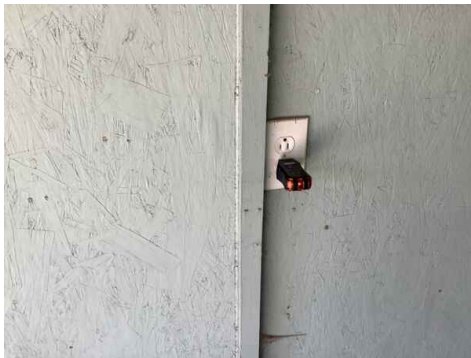
No GFCI protection

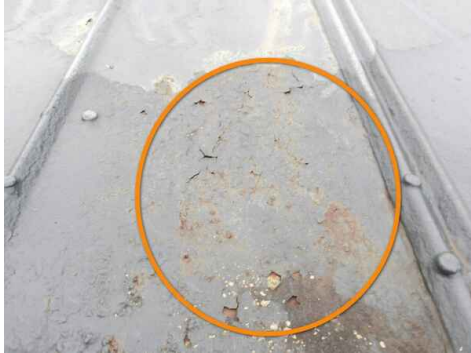
rust, chipped / peeling paint

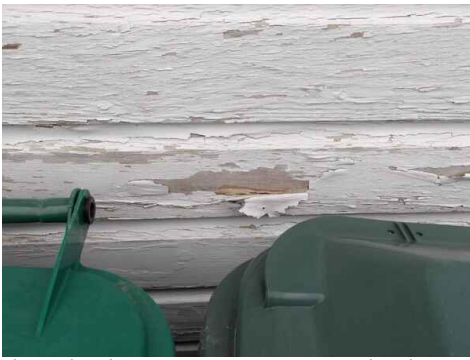
detached garage exterior wood siding, chipped / peeling paint

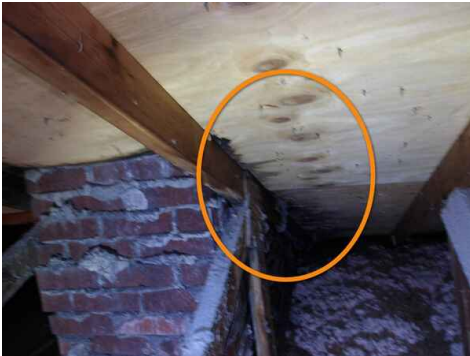
There is a sign of water (stain or damage) to the roof sheathing by the chimney.

water staining on roof decking around chimney

Recommendation
Contact a qualified professional.

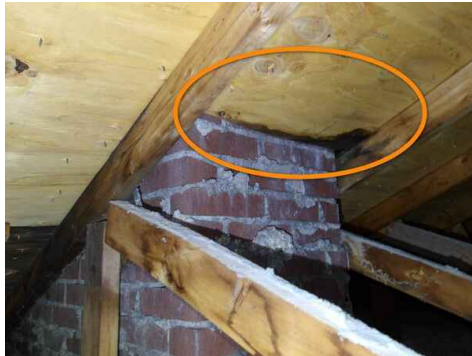
water staining on roof deck at uphill side of chimney

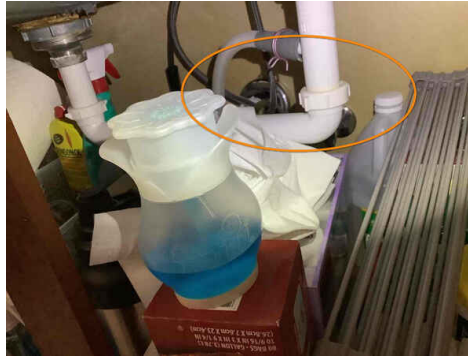
ABSENCE OF DRAIN LINE HIGH LOOP OR AIR GAP

No high loop in dishwasher drain line

The dishwasher drain line should either connect to an air system (air Admittance Valve) at the top of the sink or be installed so it has a loop in the line that touches the under side of the counter top. This air gap system or high loop will help prevent drain water from the sink draining into the dishwasher. Recommend correcting the line positioning to create this high loop.

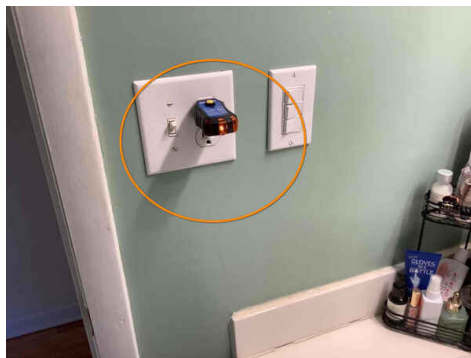
As of 1975 GFCI (Ground Fault Circuit Interrupter) protection is required on all bathroom outlets, and 1987 for kitchen outlets within 6 feet of water. Although the NEC doesn't require updates each time a new code is established GFCI protection can save lives. Recommend GFCIs be installed where currently required.

No GFCI protection, hallway shared bathroom

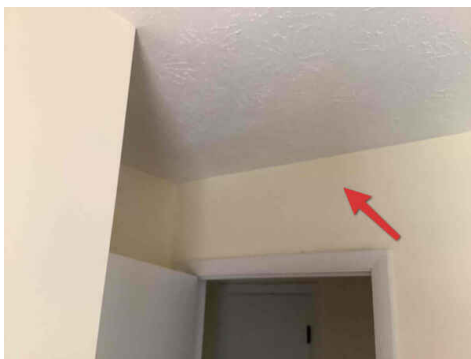
Current smoke detector safety installation standards require a smoke detector in each bedroom and in hallways outside of each bedroom (within 10 feet). They should always be installed per the manufacture's instructions.

No smoke, right front

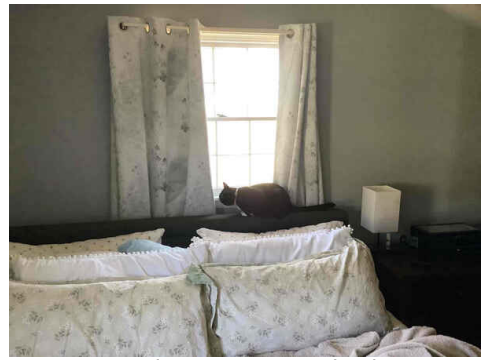
IMPROPERLY SIZED EMERGENCY EGRESS WINDOW

Largest window in primary bedroom, 15x35 inches, 3.7 sq.ft.
